# Tree Condition & Management Report 2025

Aldbrough St John Parish Council

August 2025

#### 3.2 Willow Tree T028

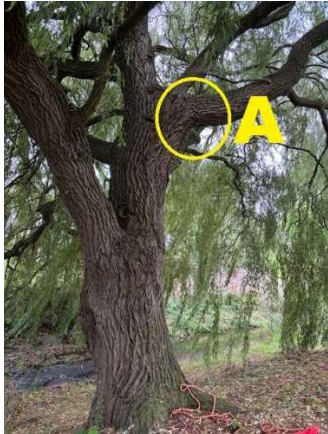
| Point A of concern to PC, appears structural branch splitting to north west | Split appears an old failure point, good wound wood outside and rib inside of this feature |

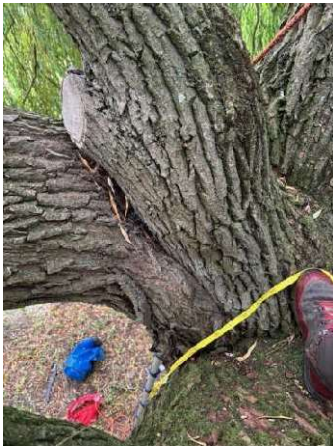
| Rear of Point A included bark, some compensatory wood growth to the side but not an ideal branch union considering the size and form of the branch from this | Structural branch to south east – appears a large issue from ground but from above there appears ample new/compensatory wood growth around this feature |

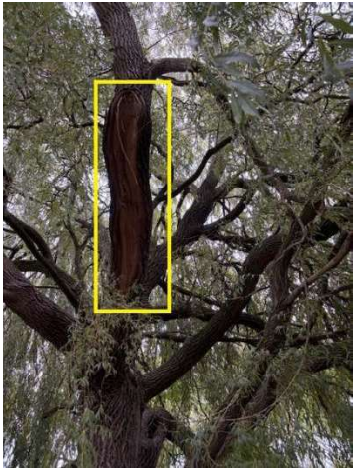
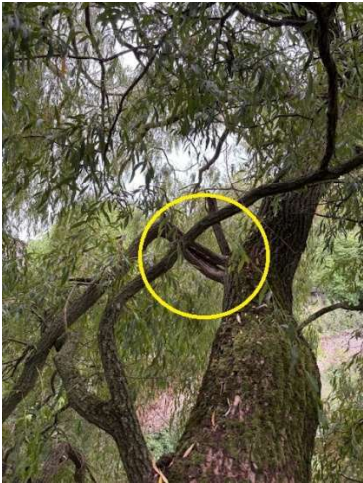
This tree has a history of branch failures. This is normal for this tree type and cannot be fully avoided. Previously observed branch failures by the PC have prompted a rope barrier being installed at the canopy edge to reduce public access.

| Area of historic branch failures, normal for tree type | Area of historic branch failures, normal for tree type |

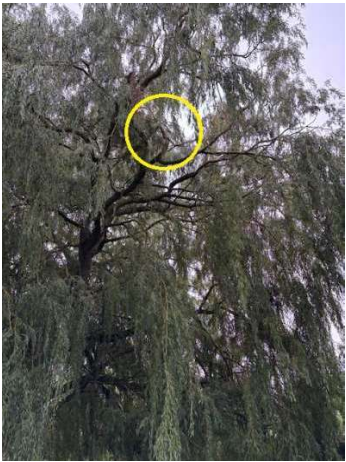
| Area of historic branch failures, normal for tree type | Approximate suggested crown reduction line shown yellow.<br>View from north east, looking south west |

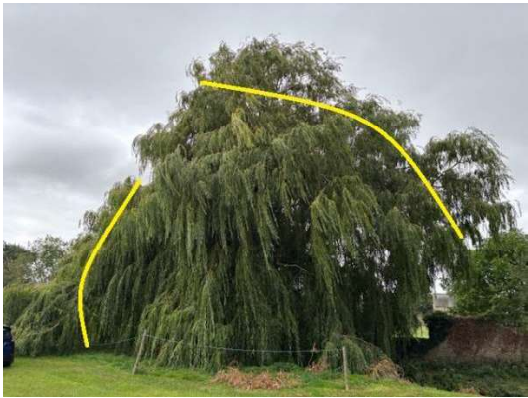
| Approximate suggested crown reduction line shown yellow.<br>View from north west, looking south east | |

| Ref. | Common Name | Height (m) | DBH (cm) | Life Stage | Target/Type | Survey Notes/Comments | Health | Work Recommendations | Timescale/Work Priority |
|---|---|---|---|---|---|---|---|---|---|
| T028 | Weeping willow | 17 | 100 | Mature | Riverside tree. | Roped off to reduce public access<br>Previous pruning works undertaken<br>Previous storm damage<br>Structural roots mechanical damage<br>Single stem at base divides into wide spreading canopy between 2.5 & 7m, branch unions mainly appear ok/normal with the exception of two to W at 4m.<br>Hollow, good wound wood on structural branch to E at 4m.<br>Dead branches 5-10cm diam. | Good | Crown reduce all leading branches by 4m to appropriate live side branch while retaining general shape of existing tree<br>Remove split branches from internal canopy<br>Remove dead branches >5cm diameter<br>Tree is still likely to see branch failures in the future as that is the strategy of willows. A sign could be installed suggesting avoidance in/after high wind events<br>See additional text and photographs in report | Low |
