Inspected by **Mike Banks**

**Visual/Operational**—

Date 13<sup>th</sup> August 2026

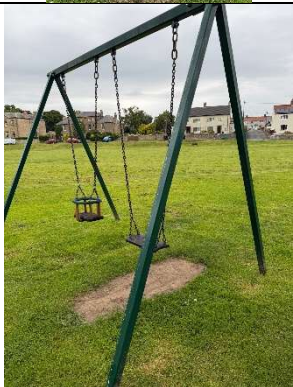
| Cradle free from defects | ✓ | | |

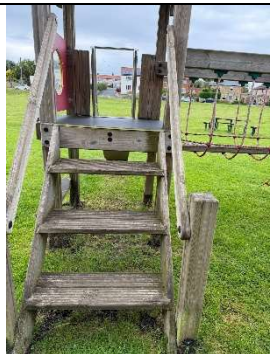
| Steps/handrails | ✓ | | |

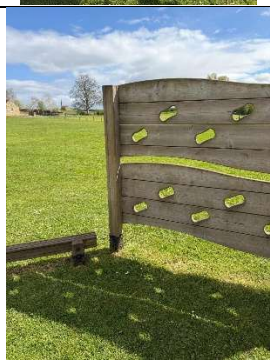
| Climbing Wall | ✓ | | |

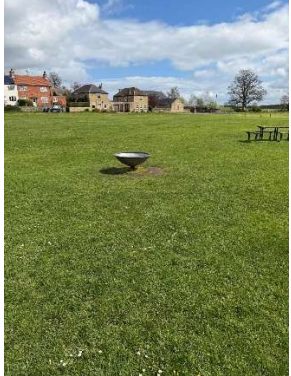
| Miscellaneous issues | X1 | Area around bowl has fall protection showing. Not an issue at the moment monitor | |

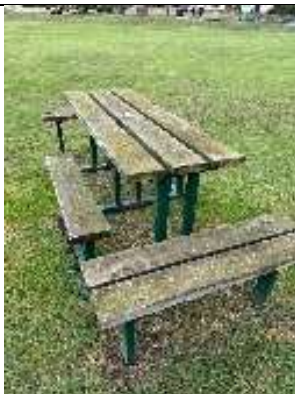
| Table surface | X1 | Table requires rubbing down and treating to protect integrity | |

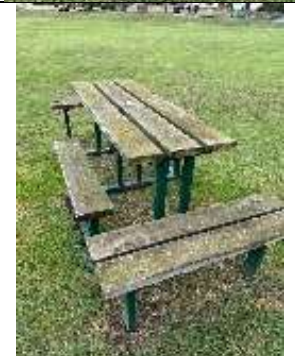
| Seats | X1 | Seats require rubbing down and treating to protect integrity | |

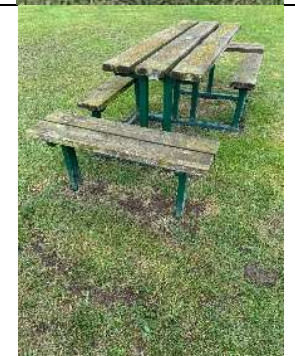
| Metal framework | X1 | Paintwork chipped around frame<br>Seat frame loose in ground not a danger but needs regrouting | |
